Phase Zero Final Report

Recommendations on Composite Socket
Fabrication based upon Experimental Results

Christopher William Norfolk, PhD, and Jon Osborn, MS, MBA
SCRA / ARDI
20 June 2009

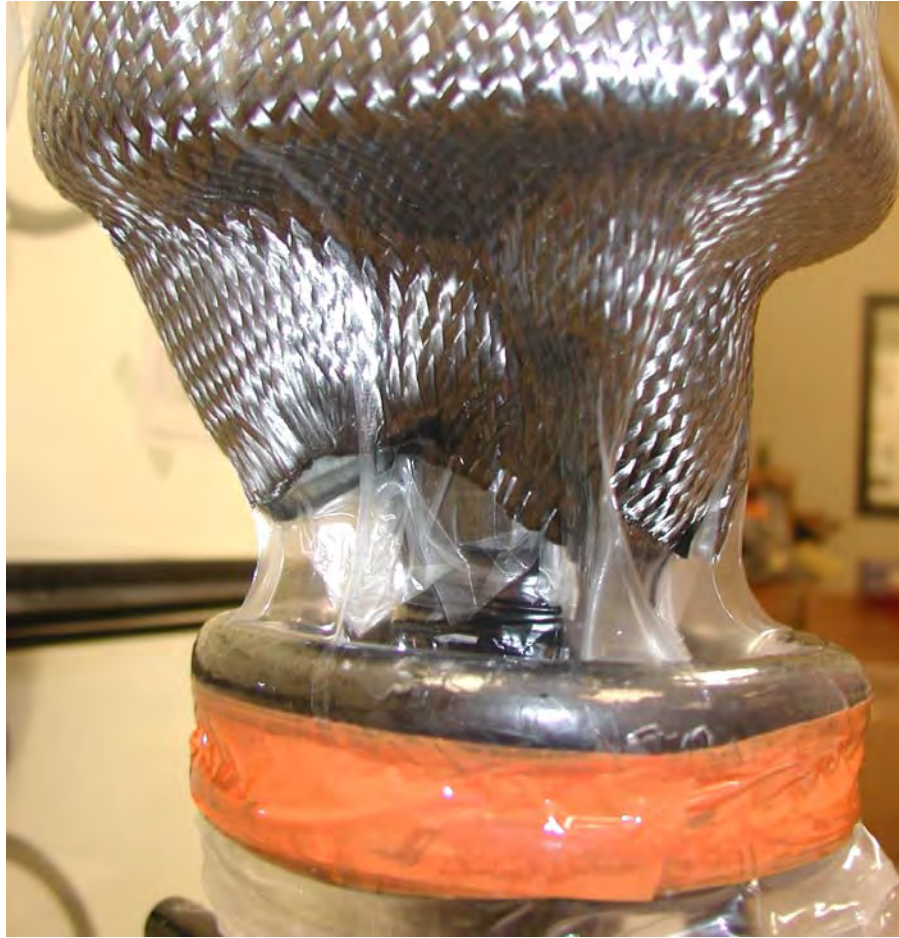
is secured in place at the bottom, and stretched tightly at the top, this collapsing effect under vacuum pressure can cause the bag to stretch and pop. This has resulted in the use of very small vacuum pressures during socket manufacturing, when compared to more traditional VARTM processing. A picture of the bag collapsing at toward the mounting pipe is shown below.

Figure 2: Illustration of the collapse of the vacuum bag

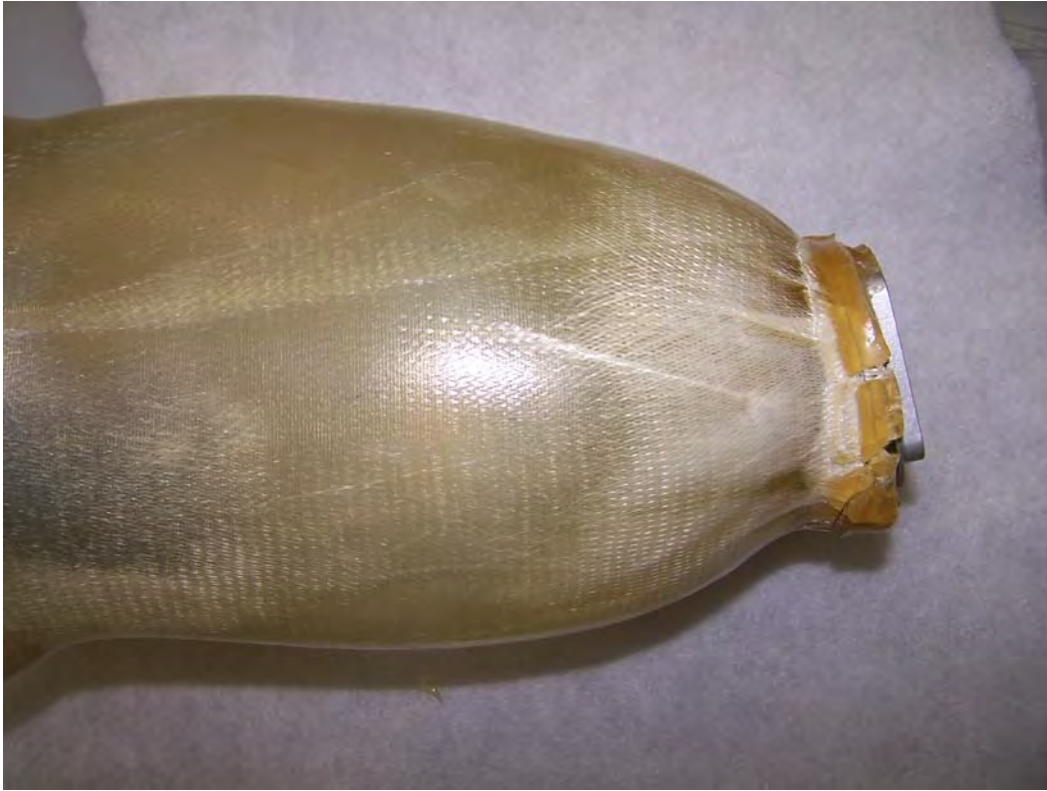
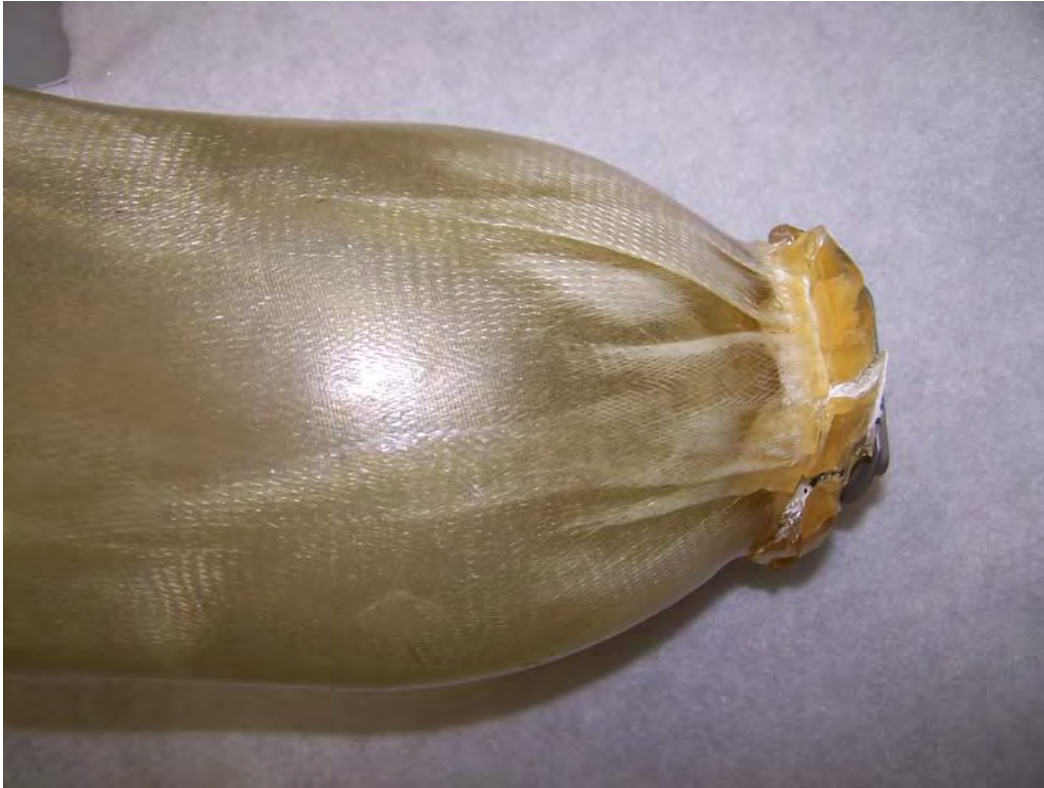
The fourth socket was fabricated from a single infusion of CMRK resin; two layers of fiberglass were placed under the attachment plate, and a single layer of fiberglass was tied into the attachment plate. The purpose of this socket was to explore the lower limit of socket strength, as this socket was envisioned to be the lowest strength socket which would ever be used clinically, and indeed is thinner than any socket I have observed. However, it was important to determine if the testing apparatus would be capable of applying loads which would fail any sockets. The ultimate strength of this socket was -8,197.7 N, which is 125% more than the P4 requirement of -3,623 N. The failure occurred at the

distal end, in the layers which were tied into the attachment plate. Note the appearance of large cracks and pulled fibers at the distal side of the attachment plate.

Figure 12: Medial close up of the failure of Socket #4

Figure 13: Posterior close up of failure of Socket #4

The series represented by sockets #4 and 5 explore the relative strength gained by using carbon over fiberglass. Their ultimate strength is very similar for the same number of layers arranged in the same configuration, and using the same resin. The carbon has only a slight advantage. However, the fiberglass fabric used has a much smaller tow size, and as a consequence, three fiberglass layers represent much less total material than three carbon layers. The advantage of the carbon over the fiberglass appears to be extremely small, with respect to the static strength.

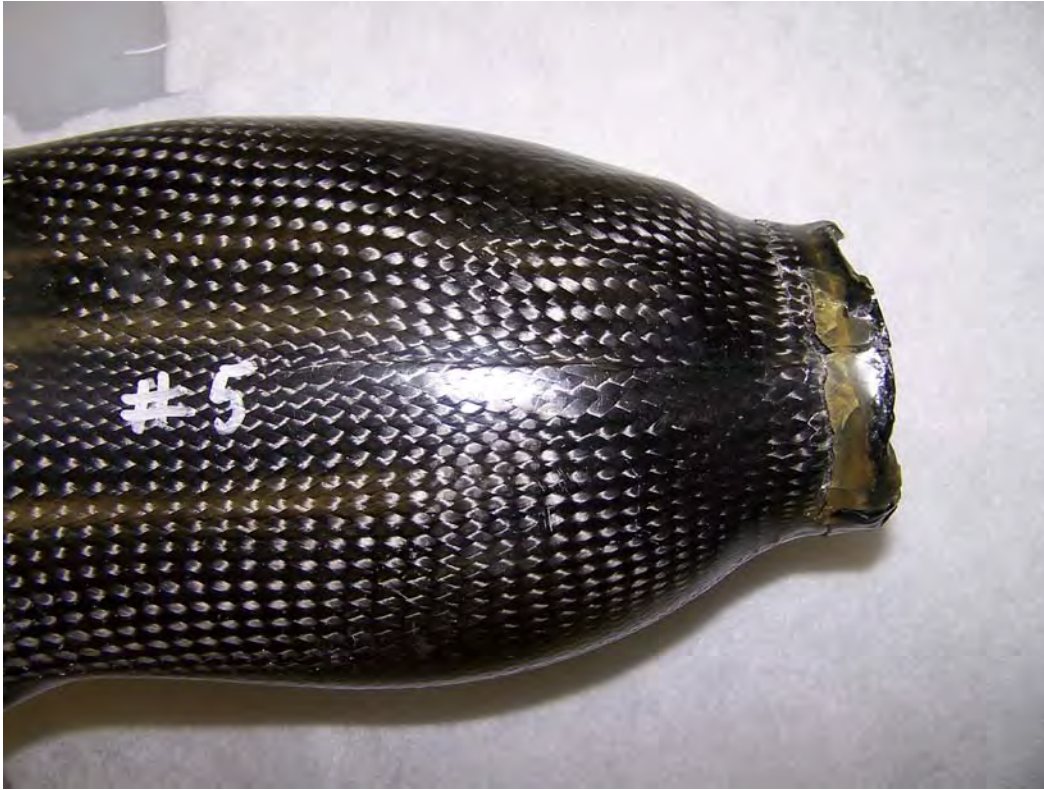
The fifth socket was fabricated using a single infusion of the CMRK resin. The reinforcement fabric used was the baseline carbon sleeve which has a tow size of 12k. Two layers were placed under the attachment plate, and a single layer was tied into the plate. It was also projected that this socket would be relatively weaker than socket #1, as there would be less carbon used in the fabrication. The socket's ultimate strength was -8,706.7 N, which is 140% more than the P4 loading required, and was indeed less than the ultimate strength of socket #1. The failure mode was again at the distal end where the attachment point was secured to the composite structure. The figure below shows a concentration of damage at the posterior near the attachment point.

Figure 14: Medial close up of the failure of Socket #5

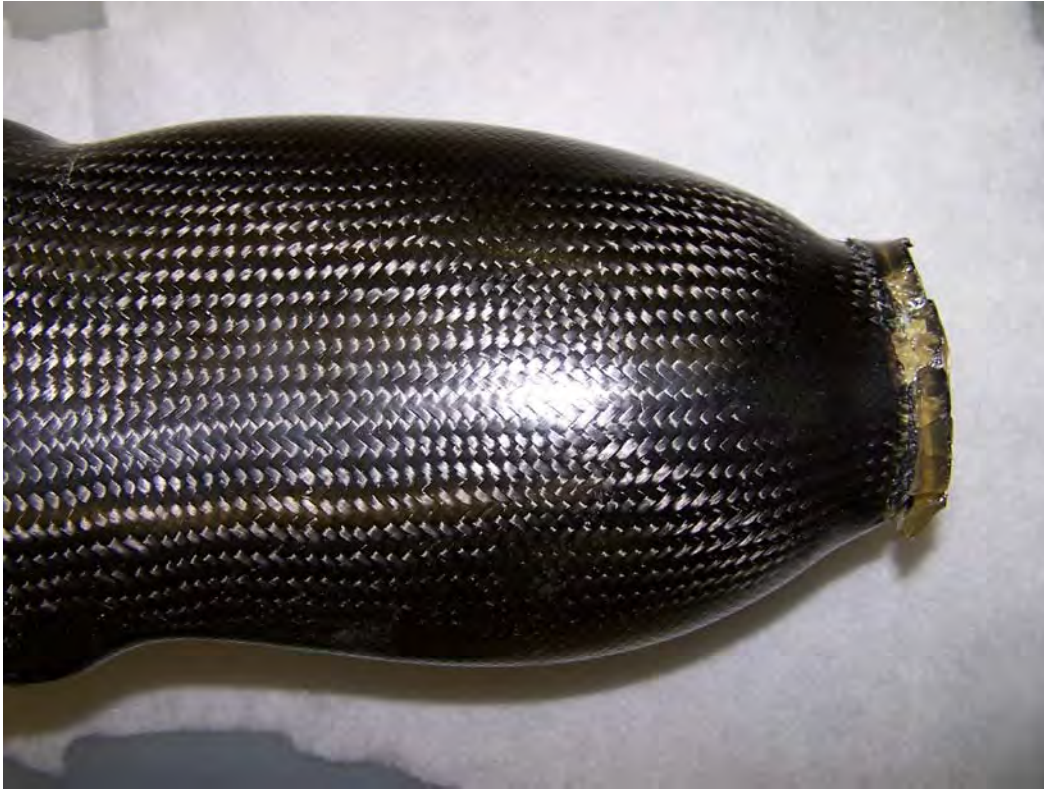
The sixth socket was fabricated using a single infusion of the CMRK resin. The reinforcement fabric used was a lightweight carbon sleeve which has a tow size of 6k. Two layers were placed under the attachment plate and a single layer was tied into the plate. It was also projected that this socket would be relatively weaker than both socket #1 and socket #5, as there would be less carbon used in the fabrication. The socket's ultimate strength was -6,279.7 N, which is 70% more than the P4 loading required. The failure mode was again at the distal end where the attachment point was secured to the composite structure. Note the concentration of damage at the posterior.

Figure 15: Medial close up of the failure of Socket #6

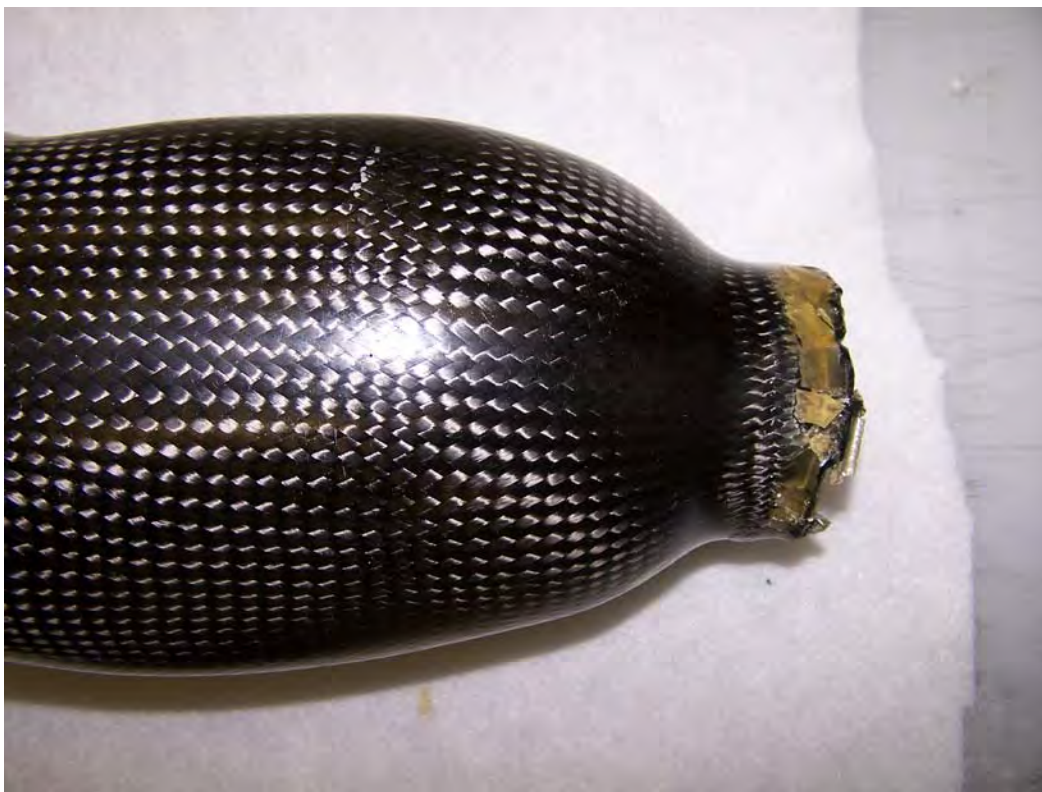
The ninth socket was fabricated using a double infusion of the CMRK resin. Two layers of carbon were placed under the attachment plate and infused in the first infusion. An additional layer of carbon was tied into the attachment plate and infused in a second infusion. The ultimate strength was -8,682.2 N, which is 140 % of more than the P4 loading required and statistically indistinguishable from socket #5. The failure mode was again at the distal end where the attachment point was secured to the composite structure. Note the concentration of damage at the distal end.

Figure 16: Lateral close up of failure of Socket #9

The series represented by sockets #4 and #9 explores the effect on the static strength of a single infusion versus a double infusion fabrication mode. At the interface between two infusions, the bond

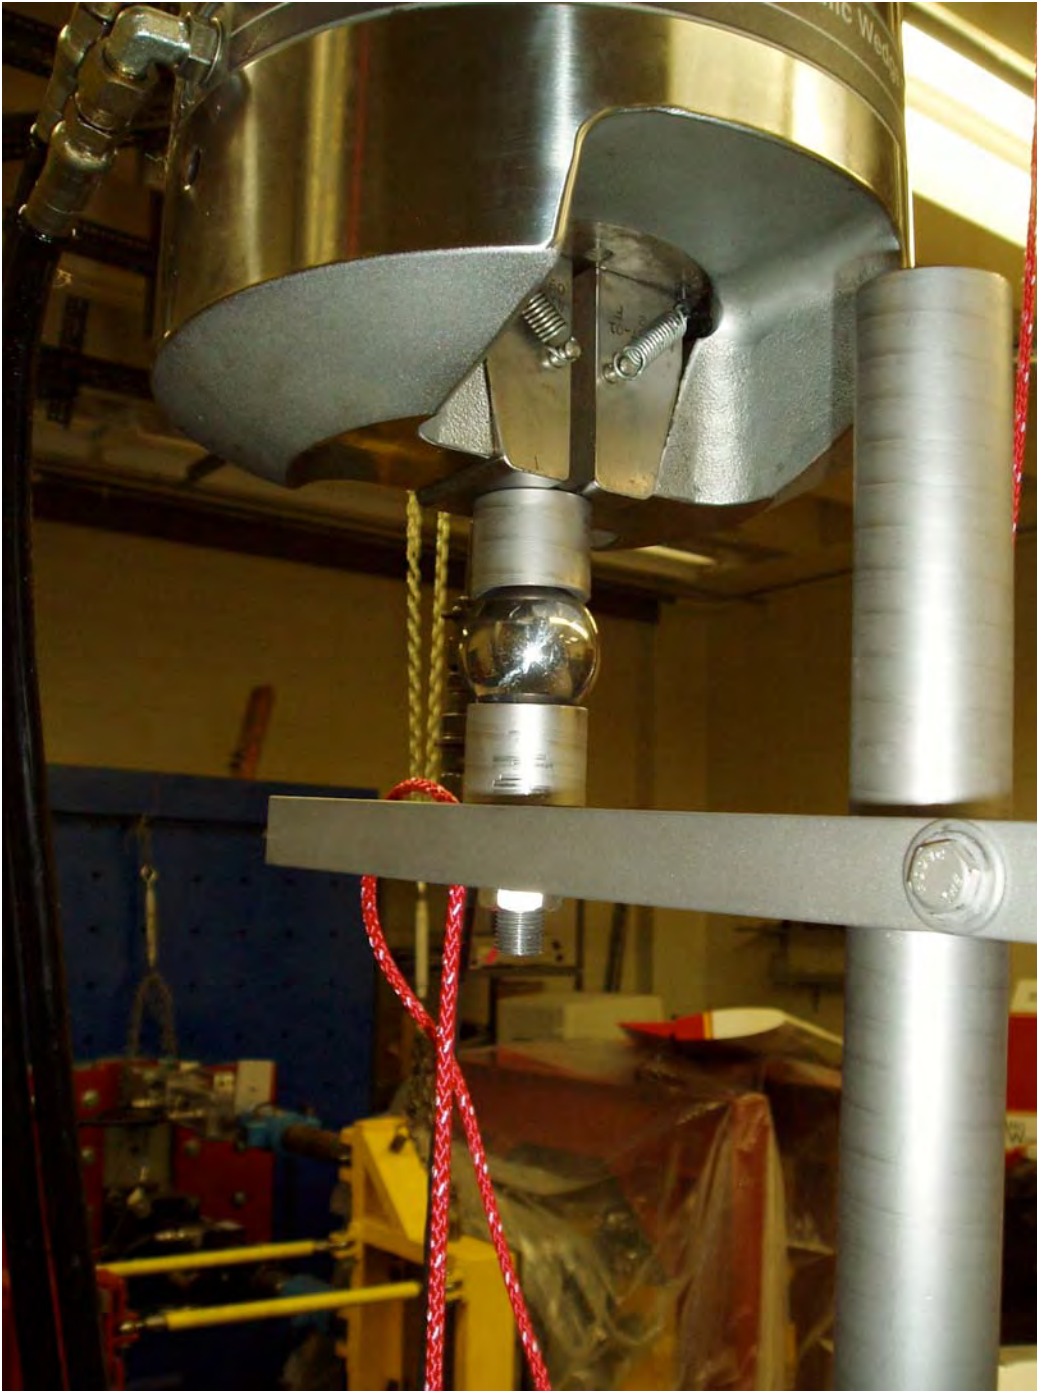
Figure 2. Distal end load fixture detail.

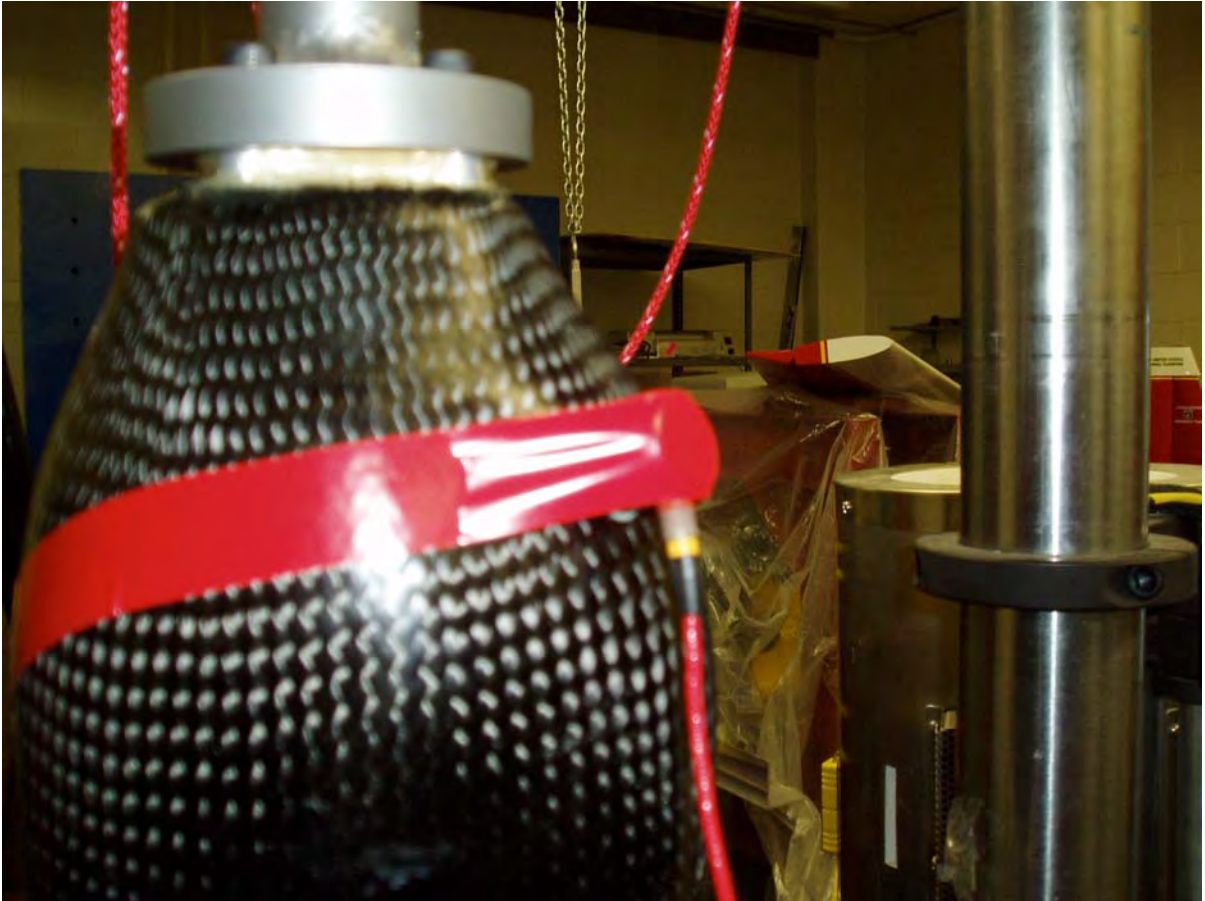
Figure 4. Acoustic emission sensor placement.

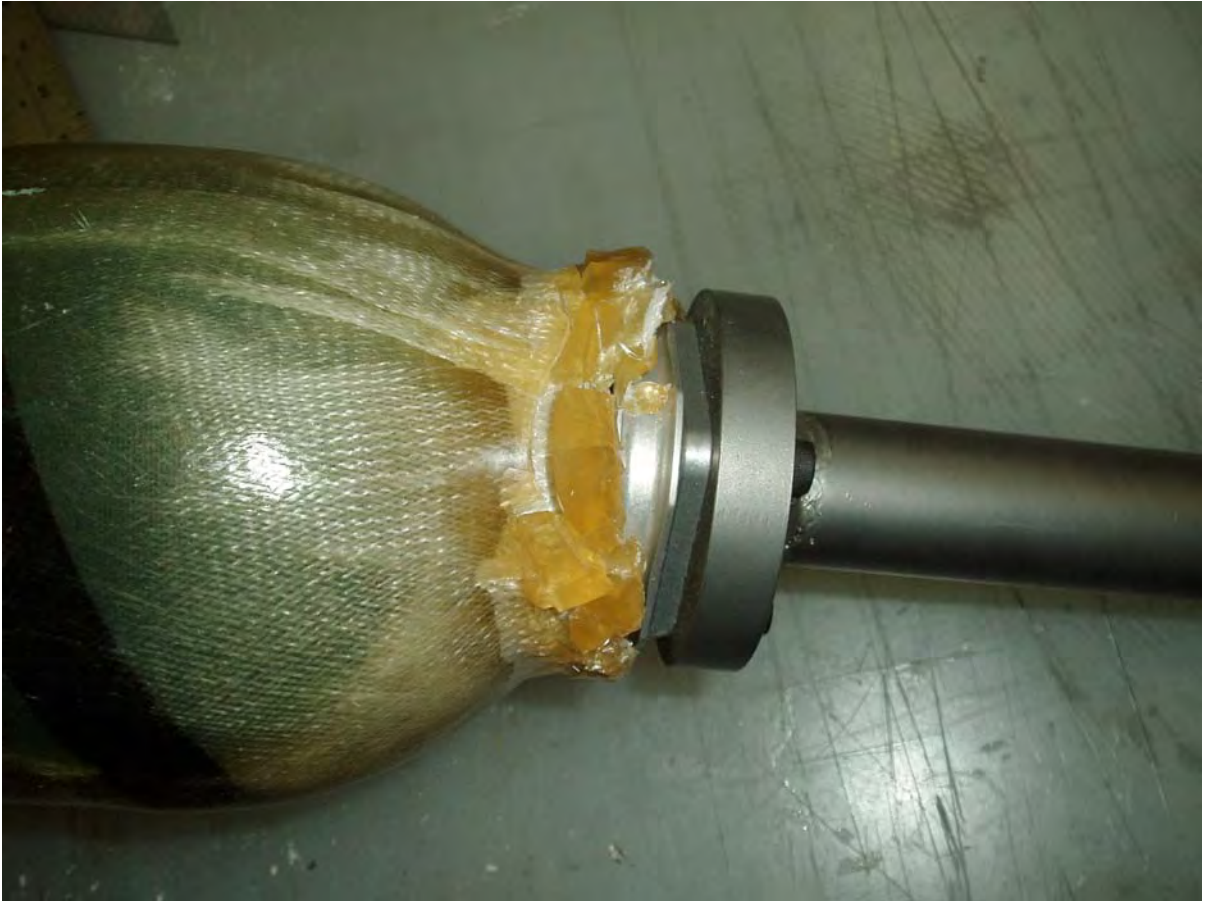
Figure 10. Failure region close-up view for socket #4.

Figure 11. Failure region close-up view for socket #4.

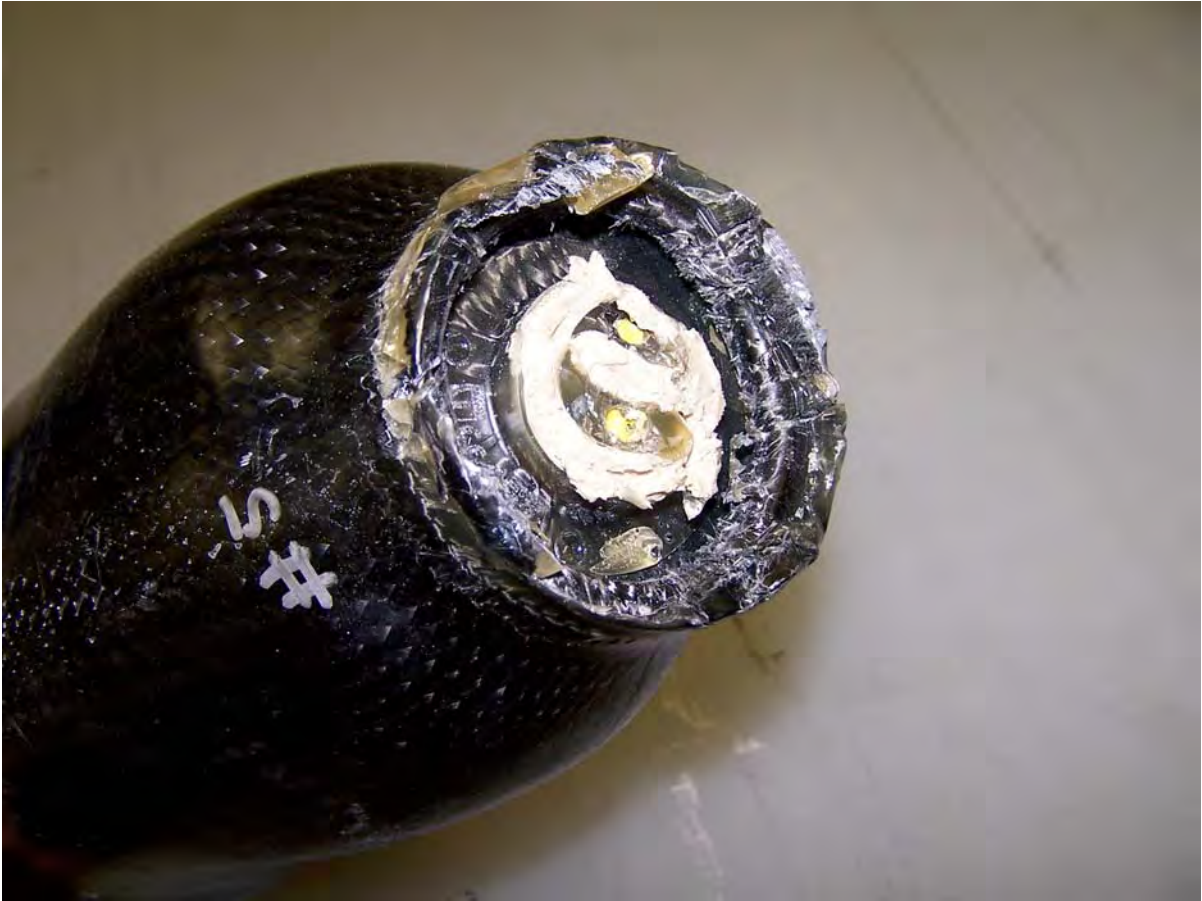
Figure 15. Failure region close-up view for socket #5.

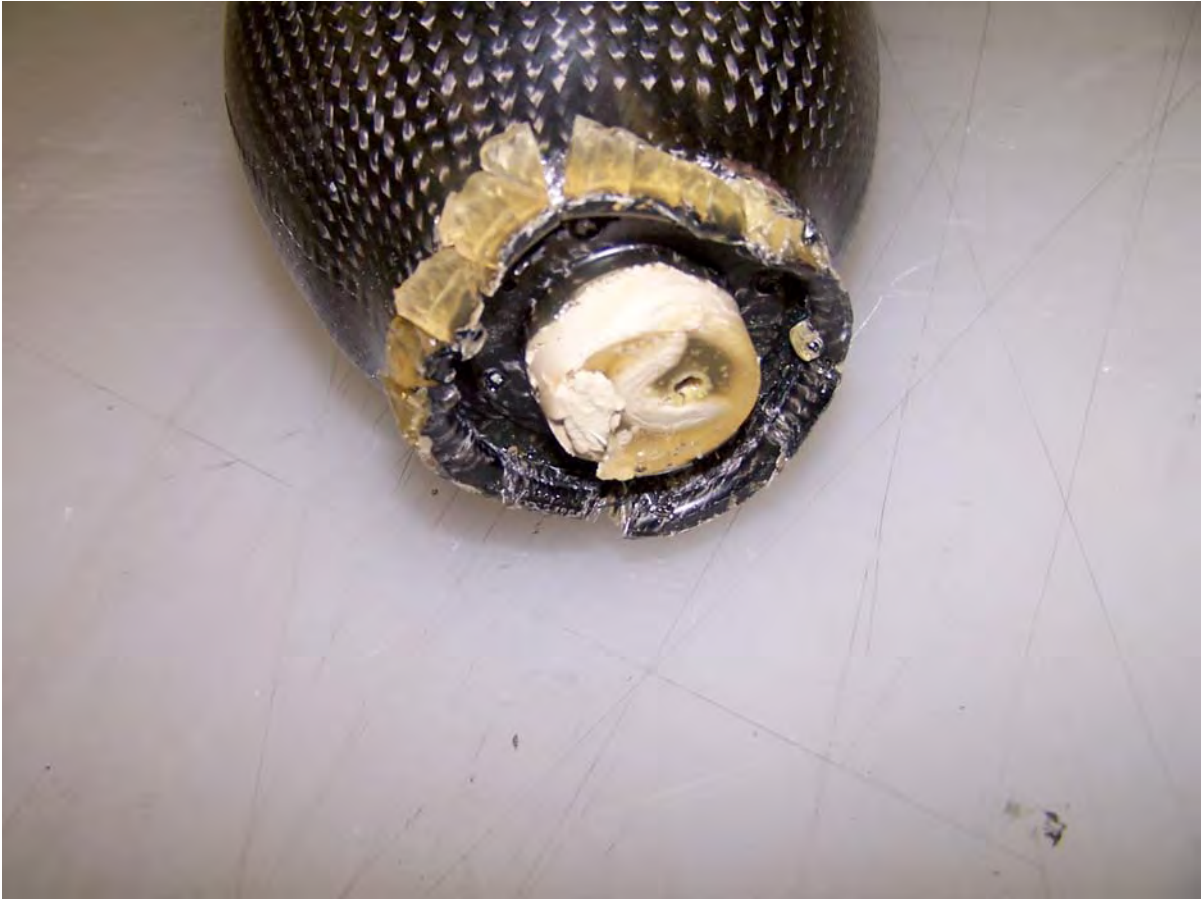
Figure 19. Failure region close-up view for socket #6.

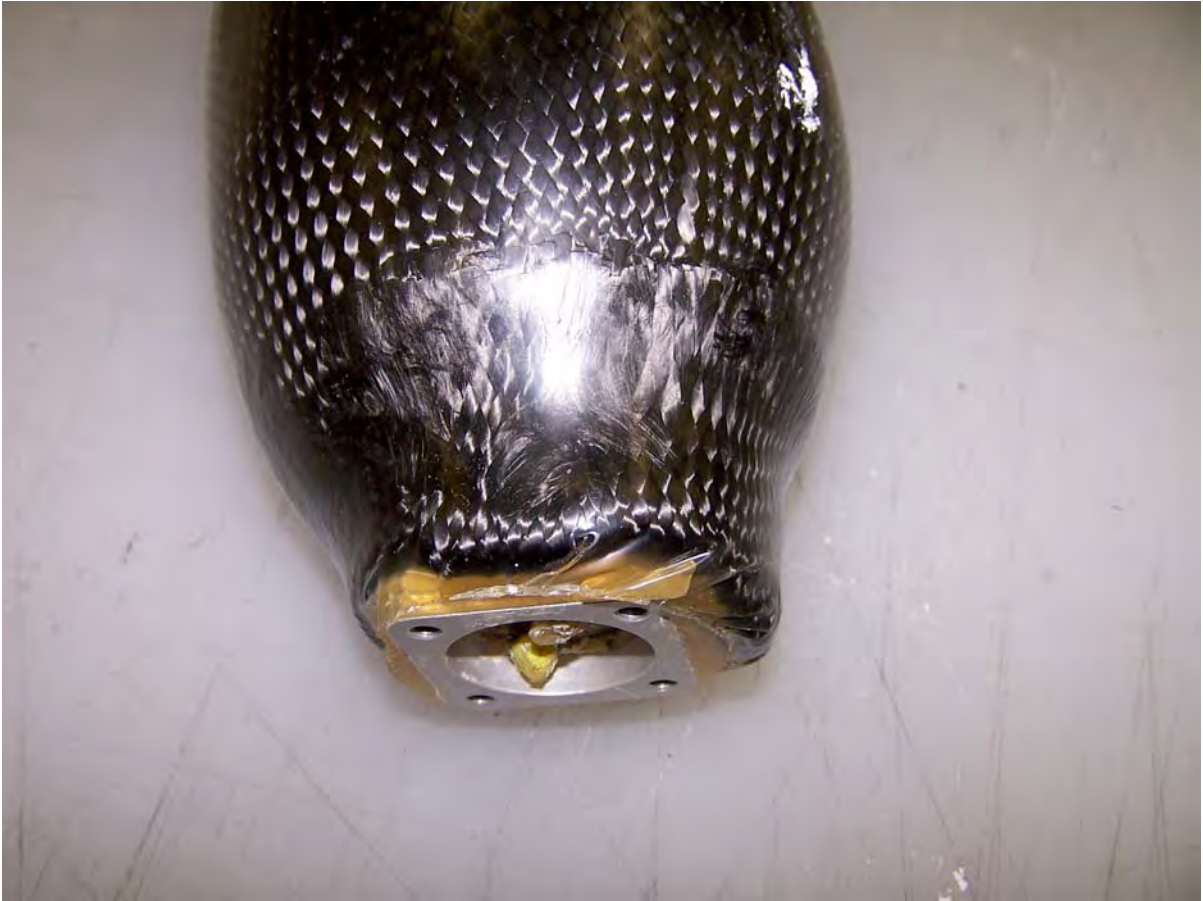
Figure 23. Distal region close-up view for socket #7.

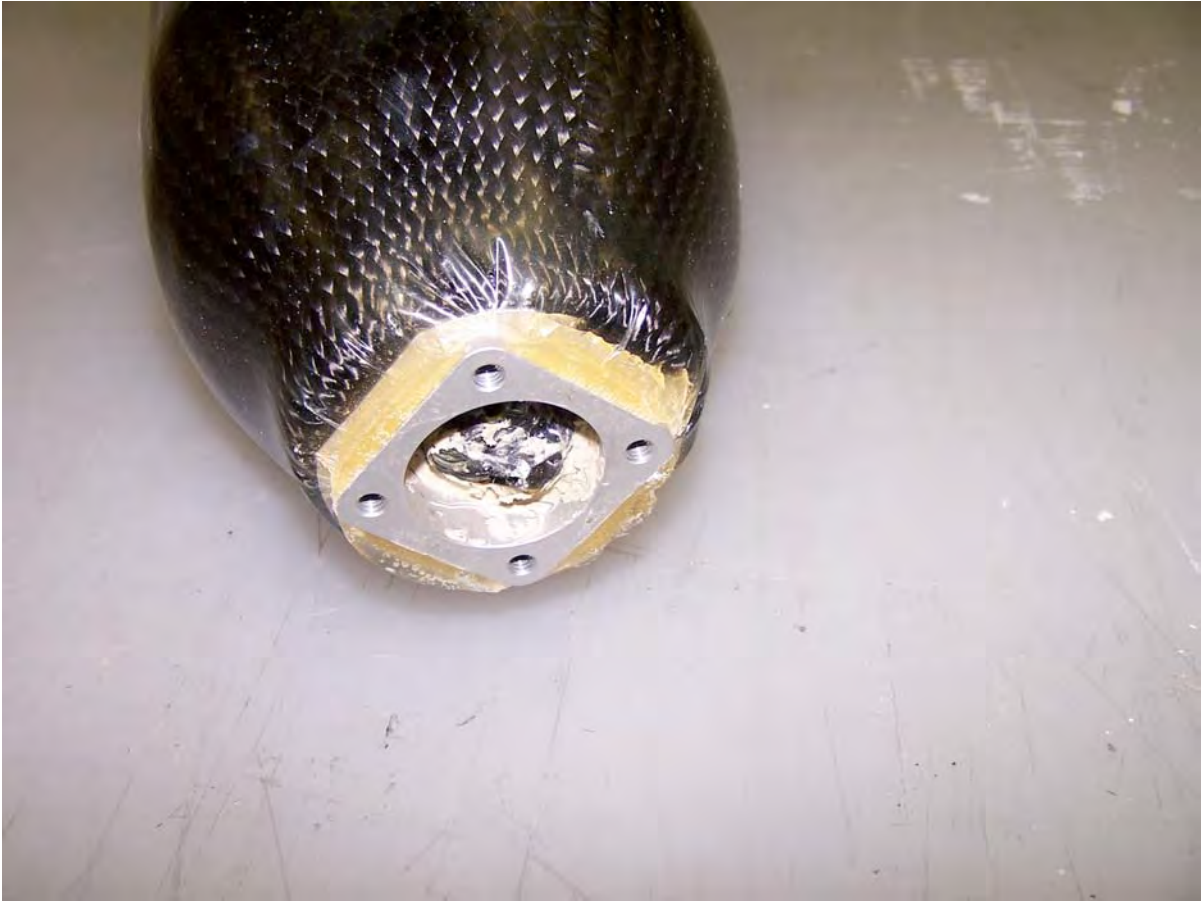
Figure 27. Distal region close-up view for socket #8.

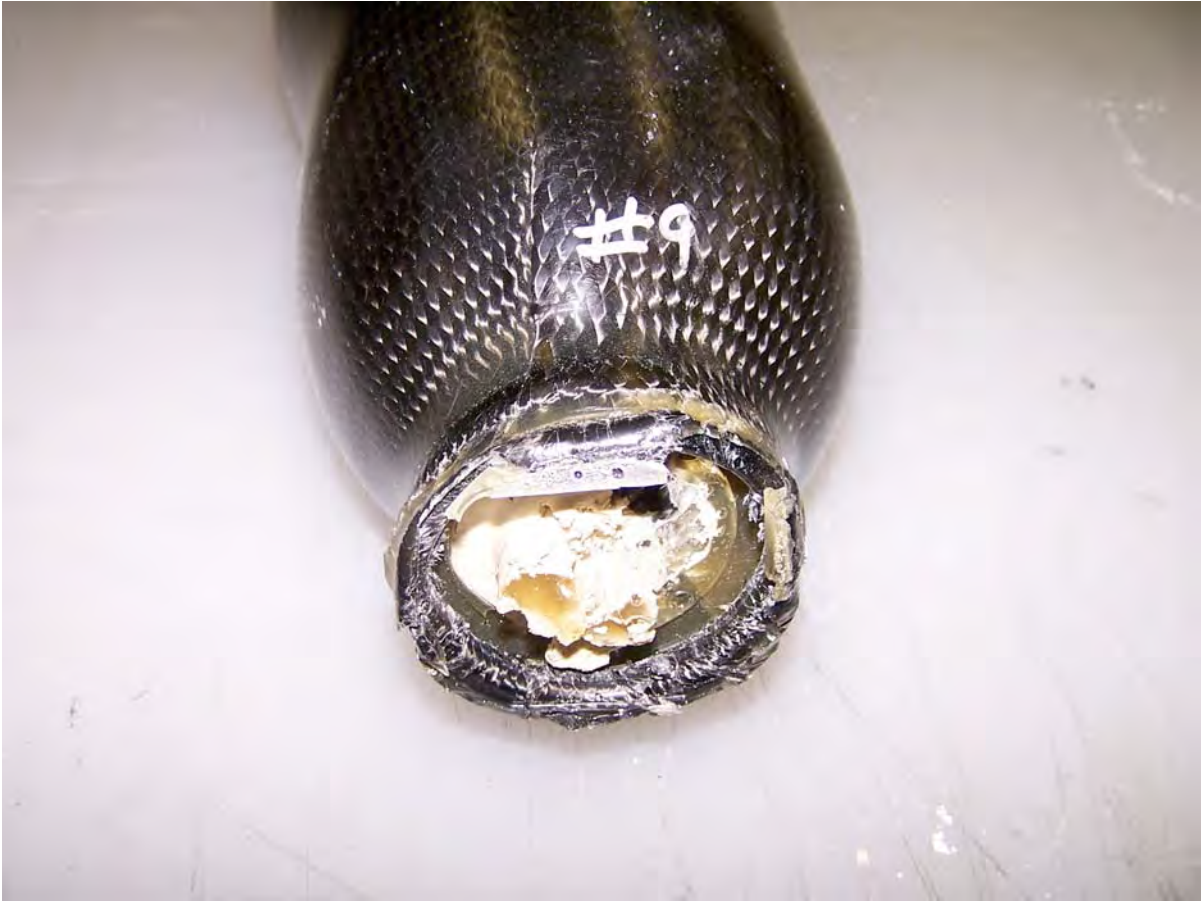
Figure 31. Failure region close-up view for socket #9.

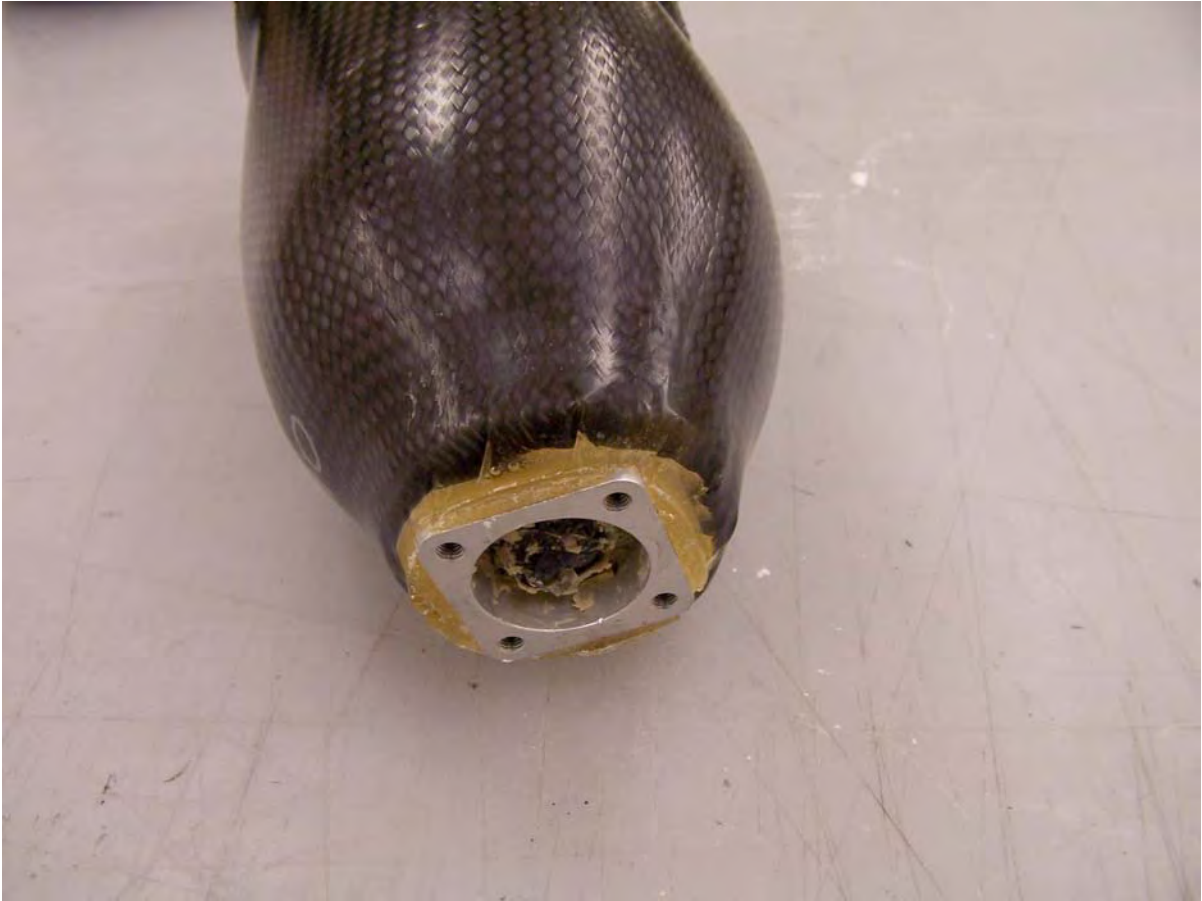
Figure 35. Distal end close-up view for socket #10.

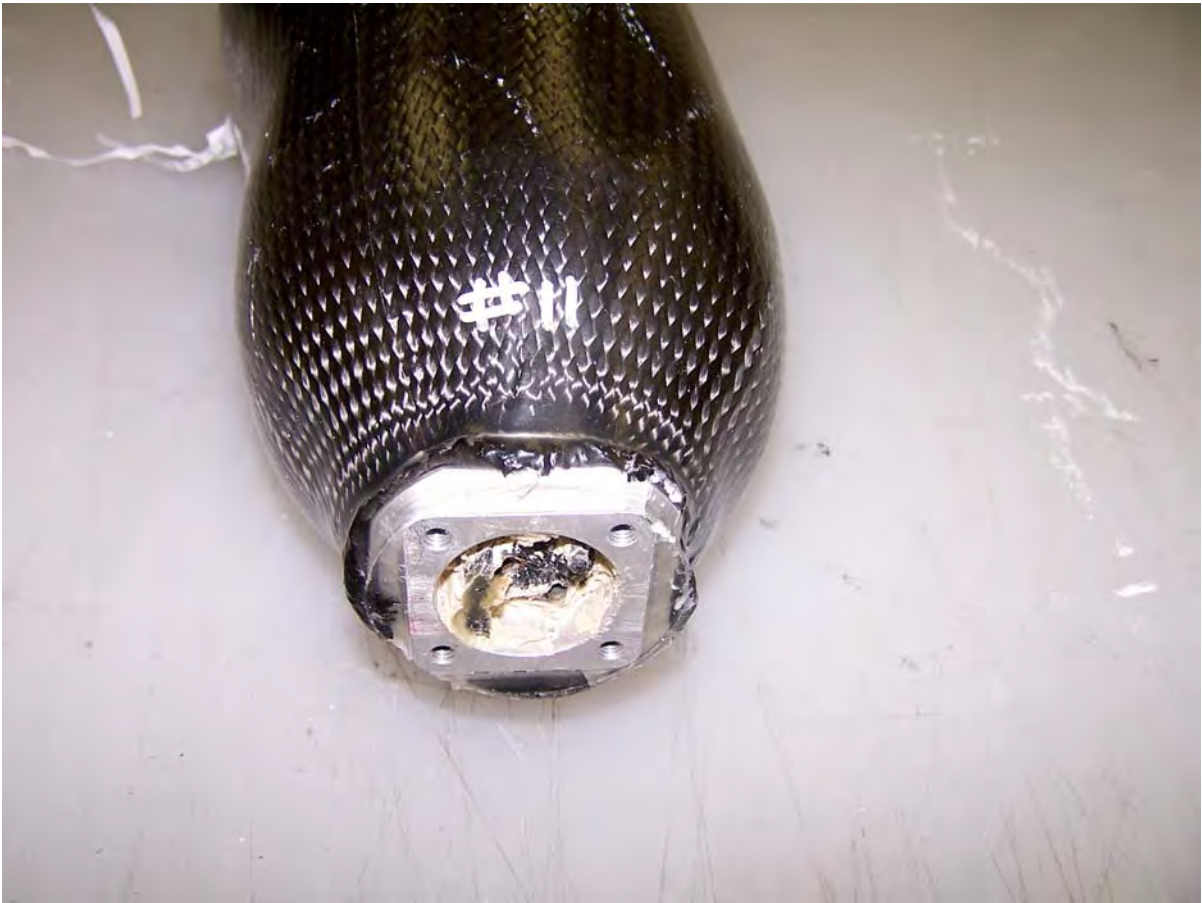
Figure 39. Distal end close-up view for socket #11.

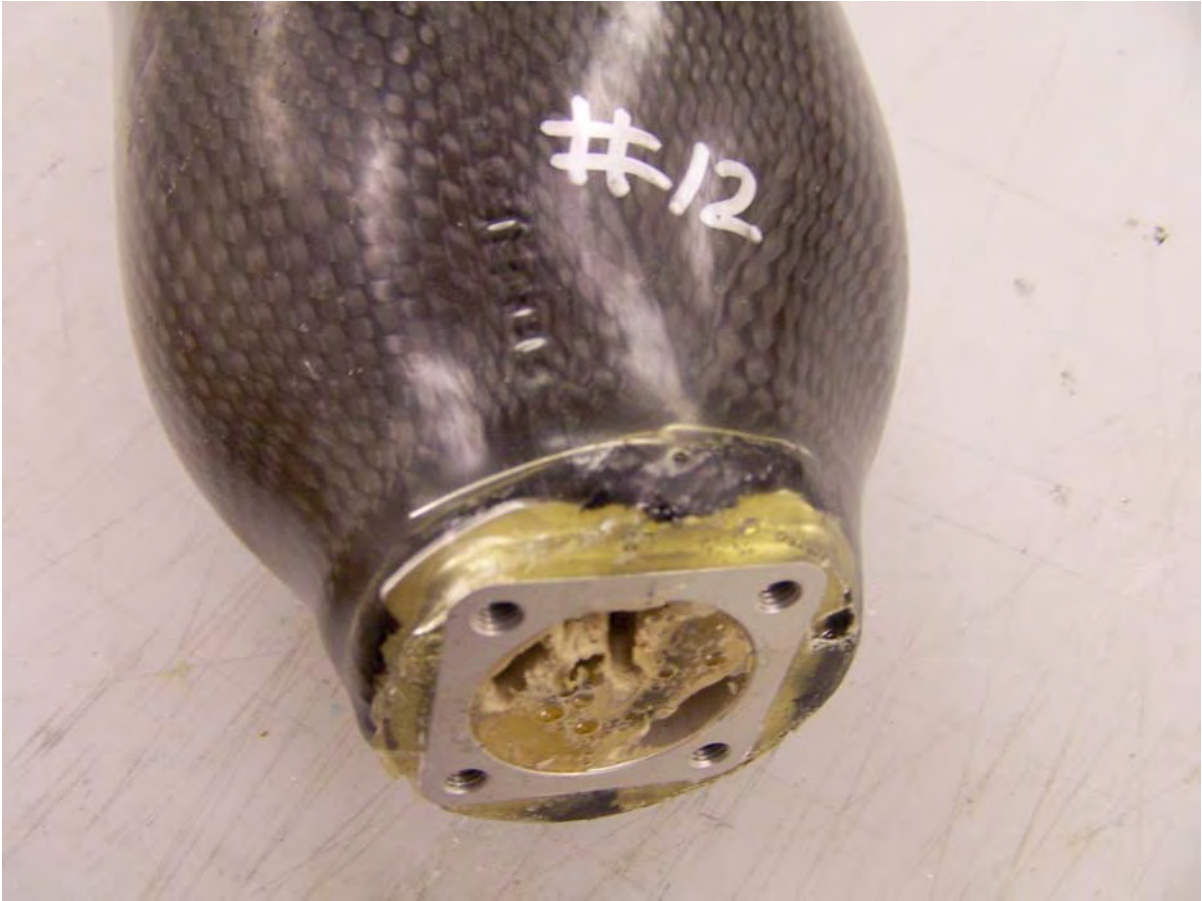
Figure 43. Distal end close-up view for socket #12.
